APPLICATION NOTE

IR TEMPERATURE MEASUREMENT ON THE PLANING LINE

FOR FIRE PROTECTION AND QUALITY CONTROL

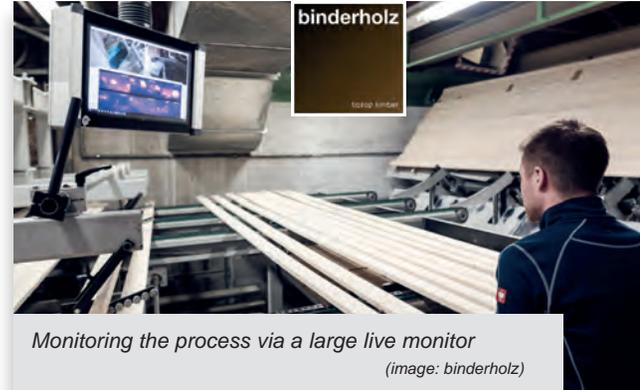
Monitoring the process via a large live monitor (image: binderholz)

The Optris cameras are also used for **quality control** in this application. Depending on the contact pressure of the stop rail, the wood surface can likewise heat up considerably – discoloration or even scorch marks are then the results. By **monitoring the wood surface** temperature by the Optris cameras directly in the machine such quality defects can be detected early and the **scrap rate** can be **reduced significantly**.

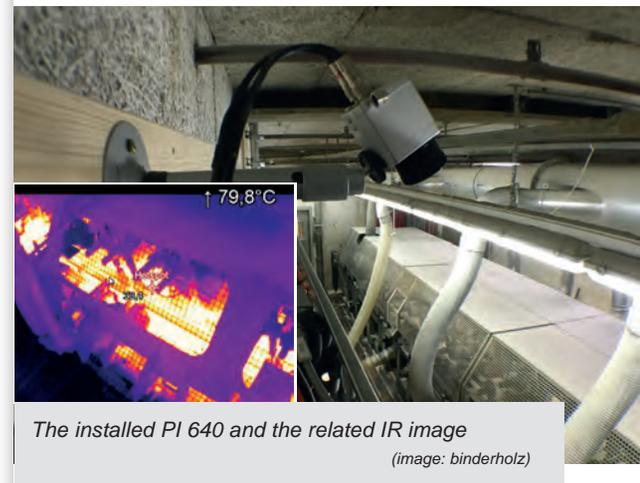
The installed PI 640 and the related IR image (image: binderholz)

To avoid the risk of fire, Optris installed Infrared temperature monitoring systems across the planing line. This system contains the optris **infrared cameras (PI 400 and PI 640)** and the license-free **software optris PIX Connect**. The compact design of the cameras is a major advantage for the application and allowed **quick and easy installation** of the system.
